Aspen First Floor Plan

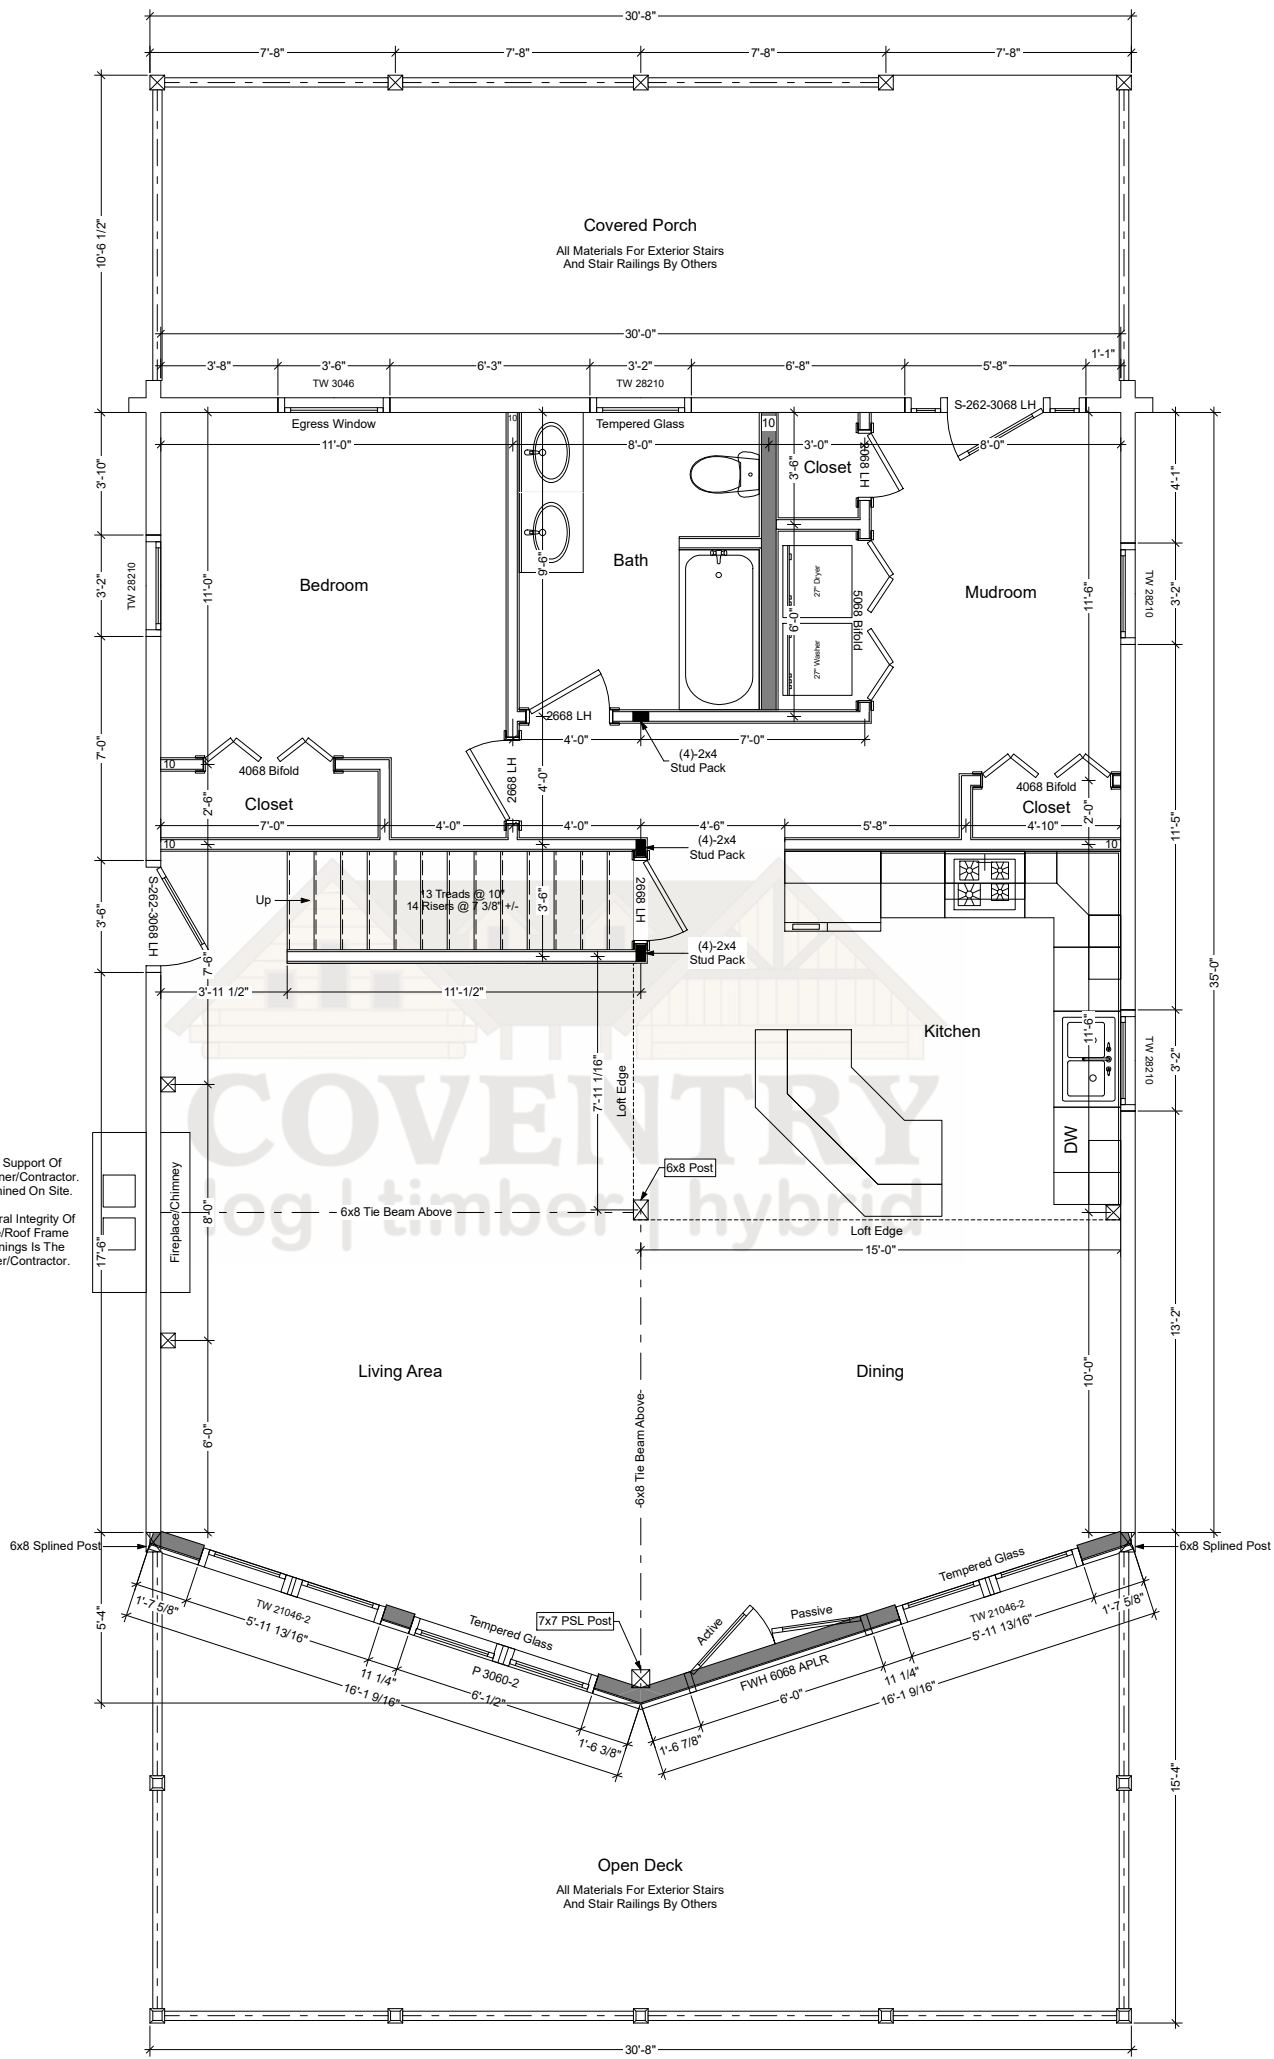
Actual Size, Location And Support Of  
Fireplace Determined By Owner/Contractor.  
Opening In Log Wall Determined On Site.

Any Compromise Of Structural Integrity Of  
The Log Walls/Floor Frame/Roof Frame  
Created By Fireplace Openings Is The  
Responsibility Of The Owner/Contractor.

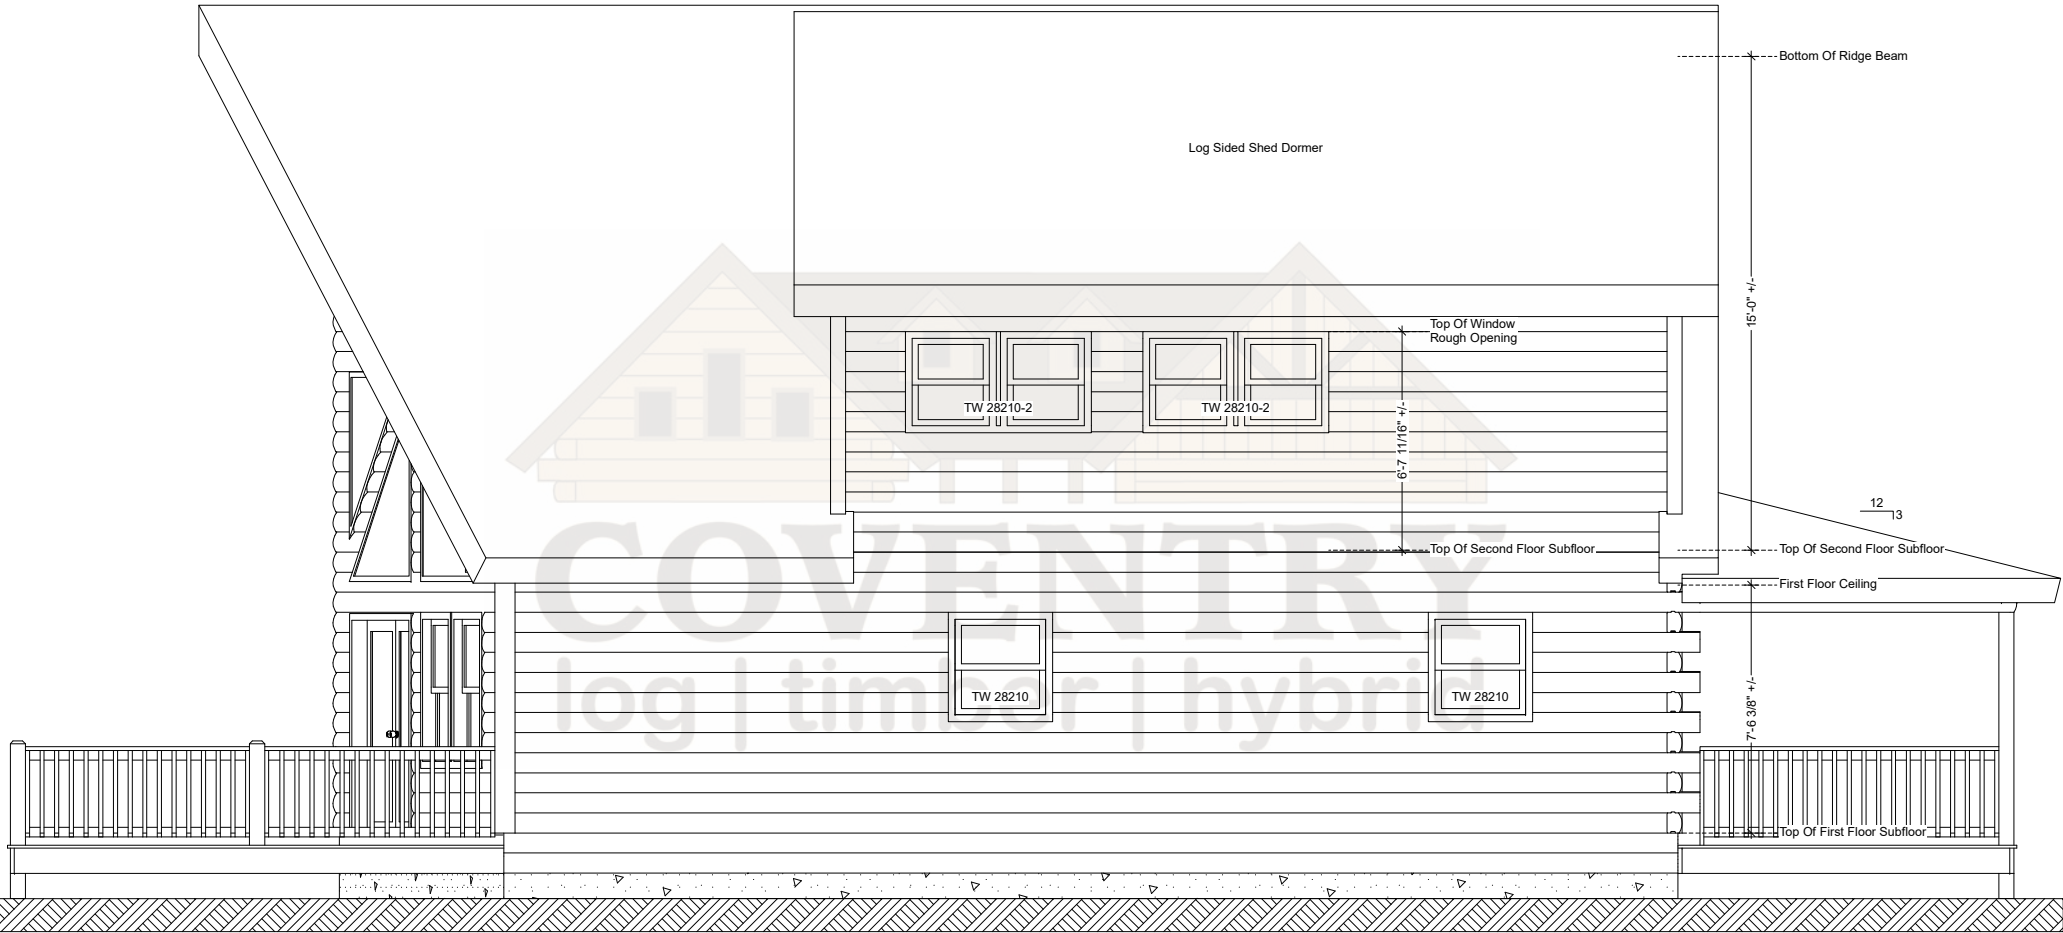
Aspen Right Elevation

Note: Actual Pitch Of Roof Determined By Assembled Log Gable.  
Pitch May Vary Slightly From That Noted On Plan.
